**LIFE RE-Vultures**

Conservation of Black and Griffon vultures in the cross-border Rhodopes mountains

# REPORT OUTLINING POWER LINES PRIORITY FOR MITIGATION MEASURES

#### TECHNICAL REPORT UNDER ACTION A6 of LIFE RE-VULTURES project LIFE14NAT/NL/901

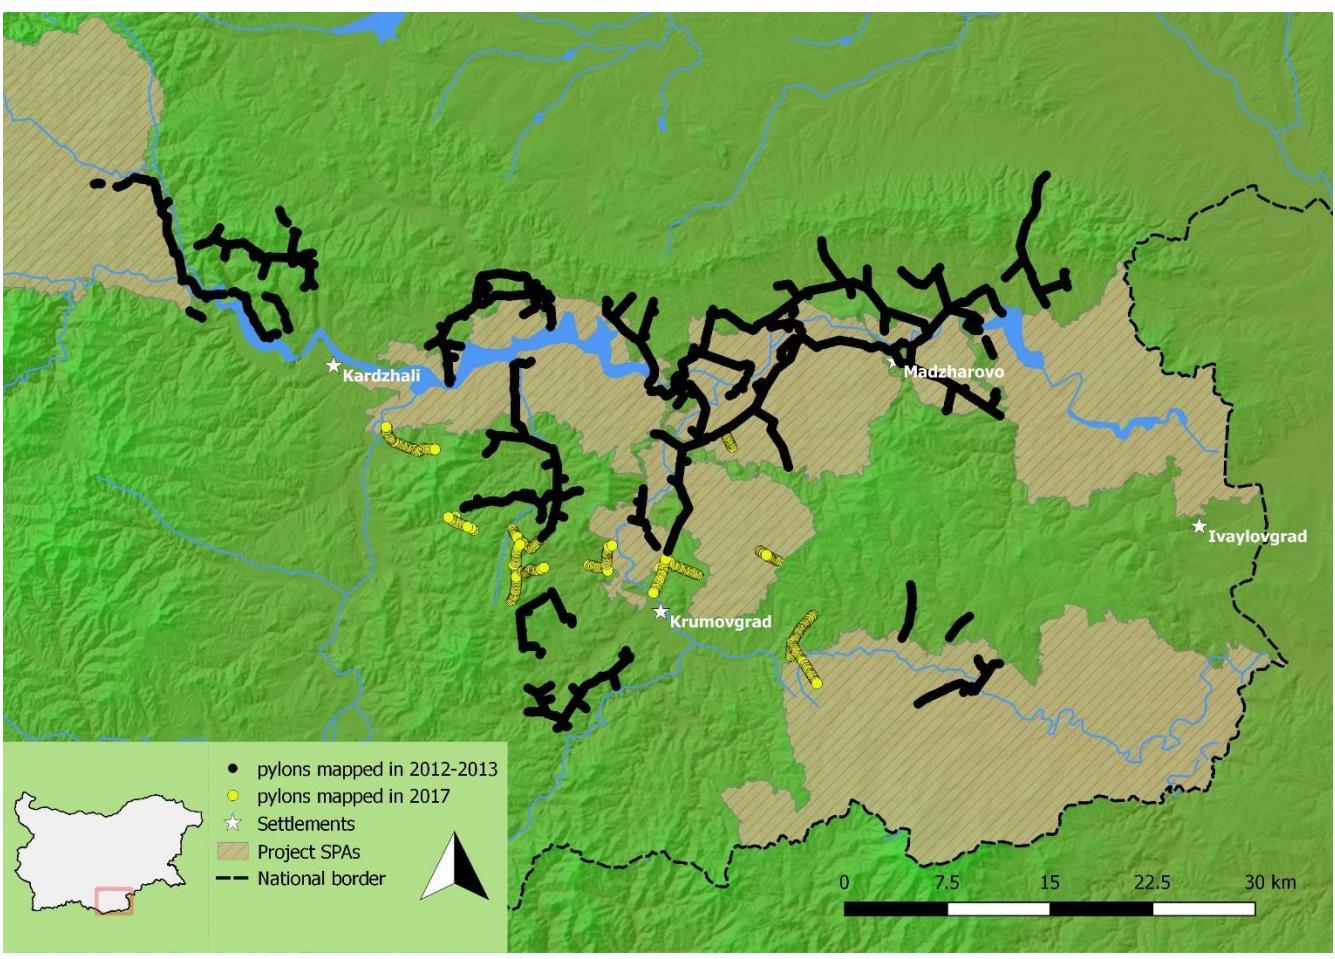
Fig. 1. Power lines mapped in the frame of the current survey and the survey in 2012-2013

This survey was carried out in the Eastern Rhodopes, Bulgaria in the period July – August 2017. As priority areas were identified territories frequently used by Griffon Vultures for foraging and roosting which was revealed by the data from the GPS telemetry of the species. This study is complimentary to a previous study on hazardous power lines in the same target SPAs in Eastern Rhodopes which was conducted in 2012 and 2013 in the frame of the project "Return of the Neophron" (LIFE10 NAT/BG/000152). Under that study all power lines in 5 km buffer around existing Egyptian Vulture nests were mapped (Dobrev et al. 2016) (Fig. 1.).

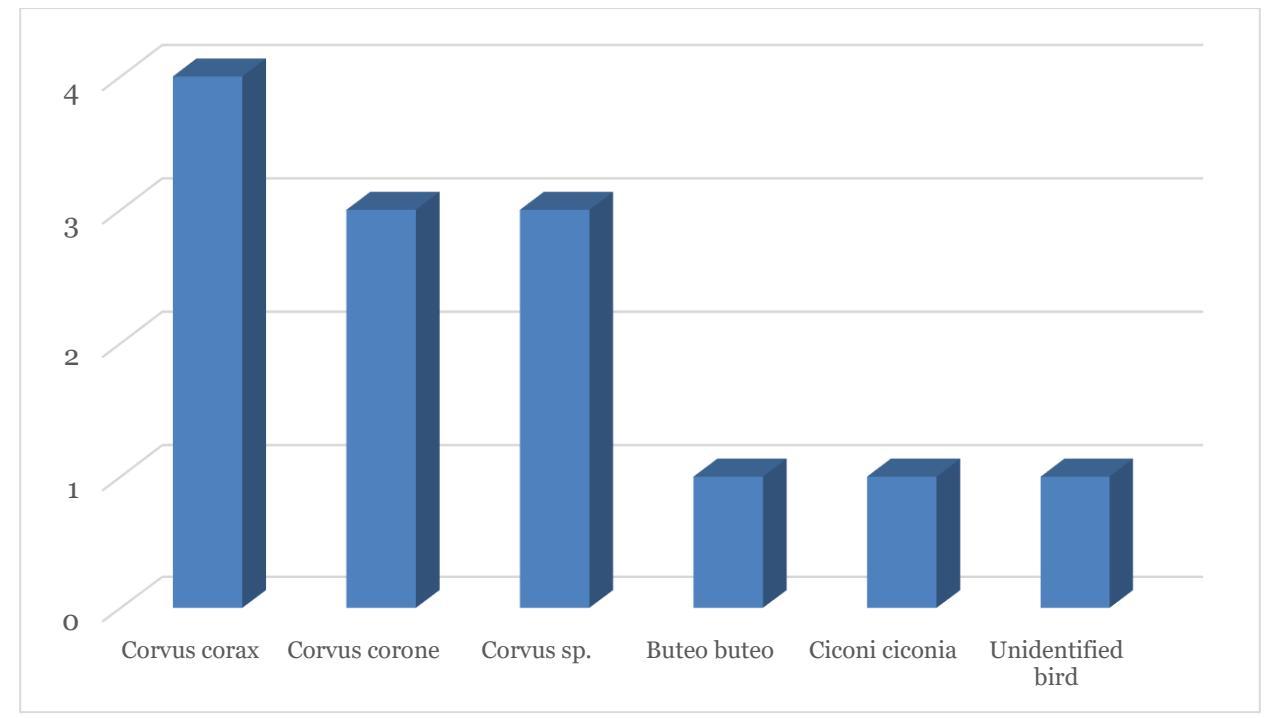
Fig. 2. Species found electrocuted and their numbers

In the frame of this study 409 poles from 30 different types along more than 20 km of power lines were mapped. In total 210 of the pylons were from two types considered among the most hazardous for birds. Ground teams found 13 corpses of dead birds under 11 hazardous power poles. All of them died due to electrocution. No victims of collision with power wires were recorded. Most of the victims were from the family Corvidae - Corvus corax – 4, Corvus corone cornix - 3 and Corvus sp. - 3. The other victims found were 1 Buteo buteo, 1 Ciconia ciconia and 1 unidentified bird. No vulture mortalities were recorded in this survey (Fig. 2). Six of the electrocuted birds were found under pylon type Vu1, another 4 were under pylon types Cr1 and Cr2 which are among the most hazardous types of pylons. All victims were found under pylons in pastures or pastures with bushes.

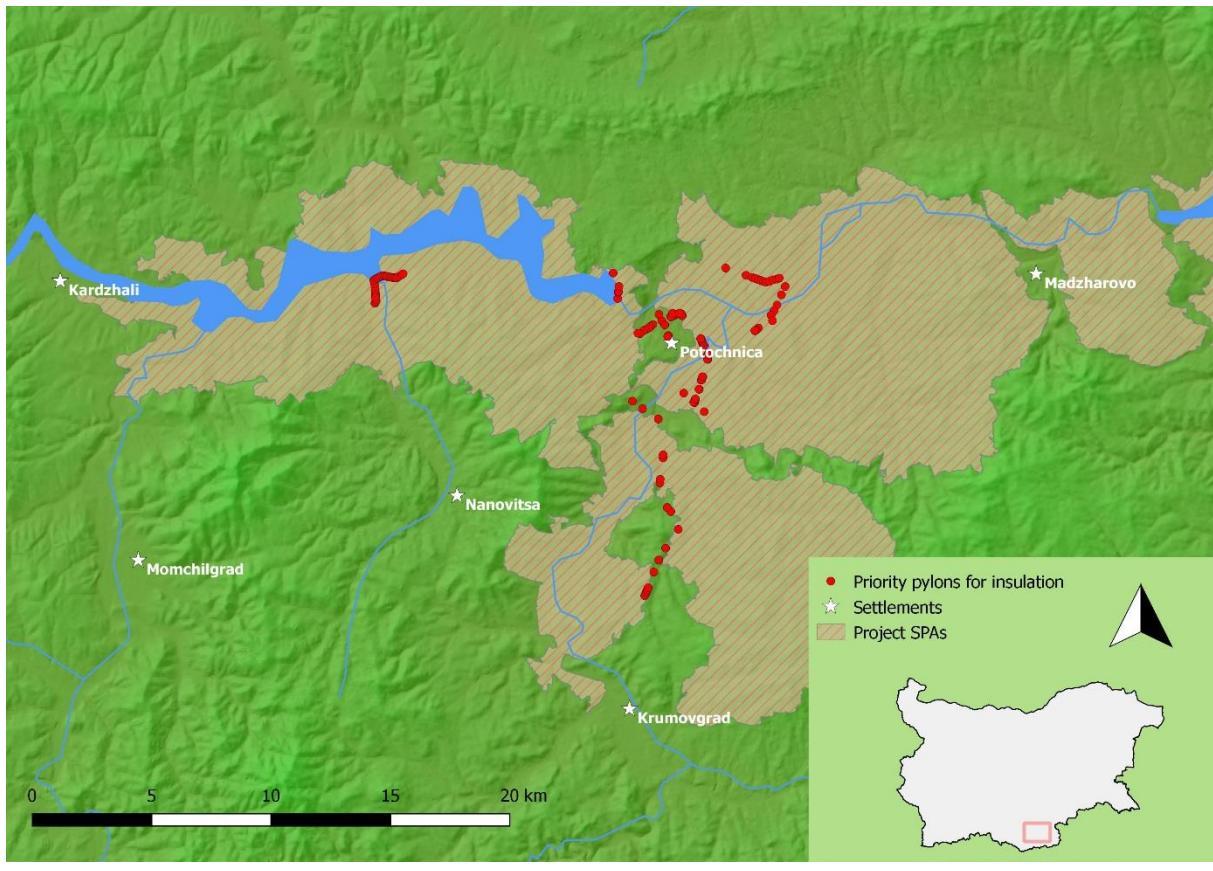
Fig. 3. Power lines priority for insulation

All data gathered from the previous and the current surveys on the hazardous power lines in Eastern Rhodopes was analyzed together. A special scoring algorithm has been developed under the project "Return of the Neophron" which was used to identify the priority pylons for insulation. The algorithm is ranking the pylons according to the threat they pose to the vultures. The electrocution risk for each pylon was assessed based on six criteria (a) pylon type, (b) accidents recorded, (c) proximity to vulture foraging areas, (d) habitat, (e) proximity to vulture nests, (f) proximity to nearest asphalt road. More on the methods used for computing this information can be found in Dobrev et al. (2016). Some of the pylons identified as priority for mitigation have been already insulated in the frame of the project "Return of the Neophron". In the current project it is foreseen that at least 120 hazardous power poles will be insulated. The highest ranked 120 pylons according to the applied algorithm were selected for insulation (Fig. 3). These are pylons posing risk of electrocution for Griffon and Egyptian vultures in the Eastern Rhodopes. The selected pylons represent 7 different types. The most numerous are the pylons from type Vu1 - 79, followed by pylons from types Vu3 and Cr1 (Fig. 4). The electricity company will be contacted and the pylons priority for insulation will be presented. However, it is expected that for some of the pylon types no insulators have been developed yet. The reasons are some technical constrains arising from the structure of the poles. In such cases these pylons will be replaced with other hazardous pylons following the results from the risk assessing algorithm. All insulated lines will be monitored to evaluate the results and provide supporting data for further insulations. Particular attention will be payed to new materials or innovative methods for insulation if such are applied in order to compare them to previous methods helping in the future selection of the best value for money materials/methods.

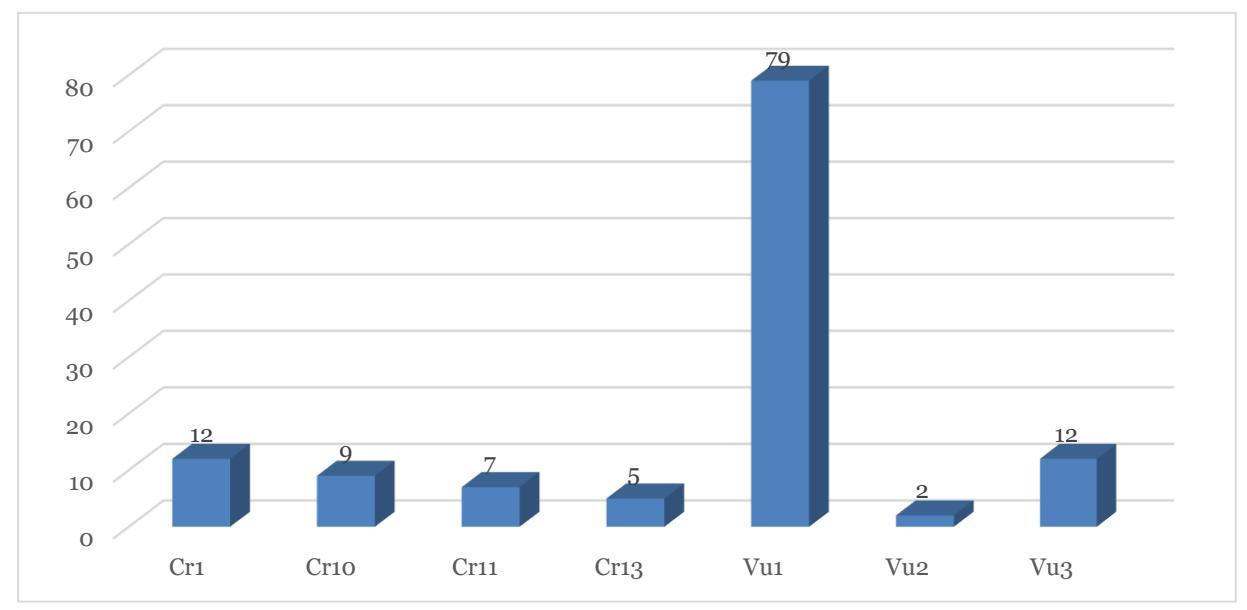
Fig. 4. Types of pylons identified as priority for insulation

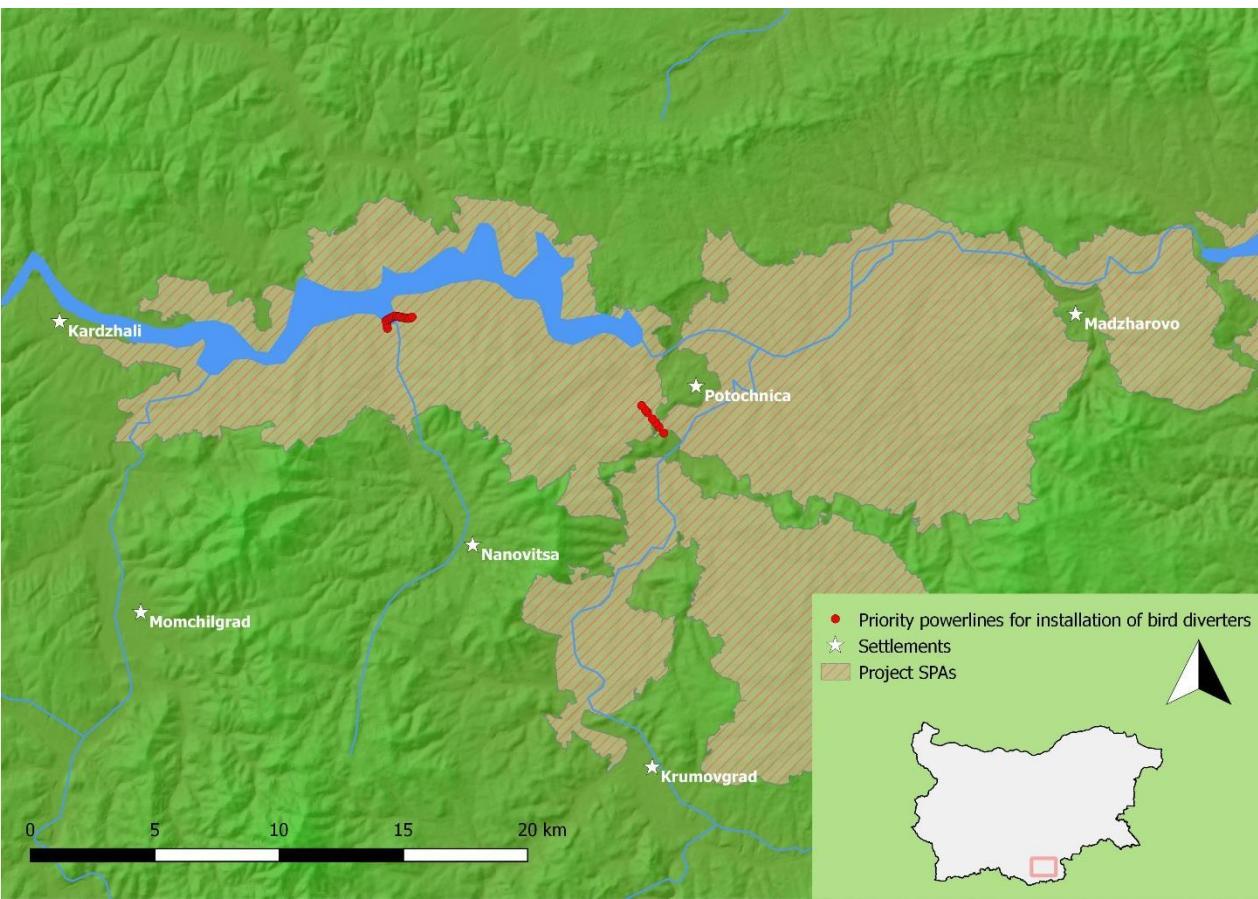
Fig. 5. Priority power lines for installation of bird diverters

In the frame of the previous and the current survey more than 7000 poles and 350 km power lines were mapped in Eastern Rhodopes. Some of these power lines are crossing territories with frequent presence of vultures. These are territories used by vultures for foraging, feeding or roosting. In the frame of the project at least 2.5 km of hazardous power lines will be equipped with bird diverters making them easily visible for birds and preventing vulture mortalities from collision with the electric wires. After analyzing the data obtained by the GPS telemetry of the Griffon Vultures and the data collected during the surveys with some older observations two power lines were identified as priority for insulation with bird diverters (Fig. 5). These power lines pose serious risk for all three vulture species inhabiting Eastern Rhodopes as they are situated near the breeding sited and near one of the feeding stations in the area. The first power line is situated on a top of a hill on the southern bank of Studen kladenets Reservoir. In 2013 one Griffon Vulture was found dead after collision with this power line. The second priority power line is situated near the feeding station in SPA Studen kladenets. It is a high voltage power line which passes near a ridge frequently used by vultures for soaring.
